Rejuvenating an historic sandstone building

Historic Treat Hall on the campus of Johnson & Wales University in Denver, CO, recently experienced a revitalization, as its sandstone exterior was restored by experts at Building Restoration Specialties, Inc. (BRS) of Denver, CO. Photo courtesy of Joshua Casto

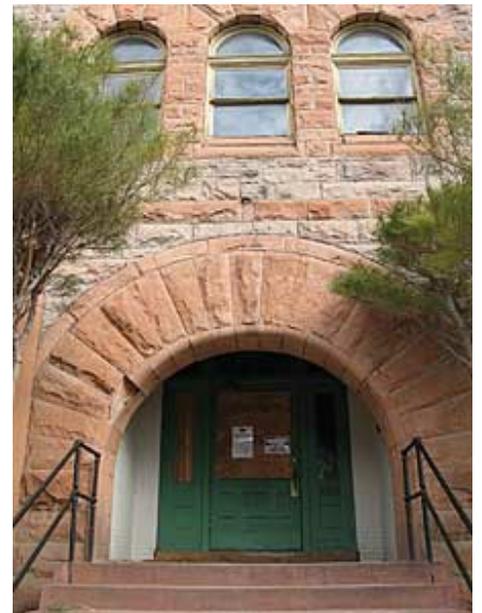
Due to the poor condition of the sandstone, many pieces were replaced with matching stone quarried in Wyoming.

Additionally, BRS located Strid Marble and Granite Company in Cheyenne, WY, which quarries a stone that is a close match to the original sandstone. “There are tall peaks on the top of the building, and we didn’t have stone wide enough,” explained Maas. “We found a quarry in Wyoming that [yields] a more dense product that is a very close match in color. We used that on water ledges, caps and windowsills - anywhere there would be water accumulating.”

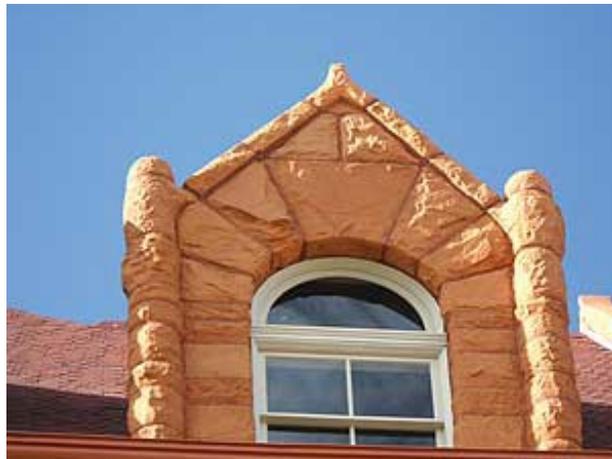
In addition to evaluating which stones could be repaired and which needed to be replaced, the restoration specialists at BRS assessed how much the building has shifted and the extent to which this had damaged the stones. Photos courtesy of Building Restoration Specialties, Inc.

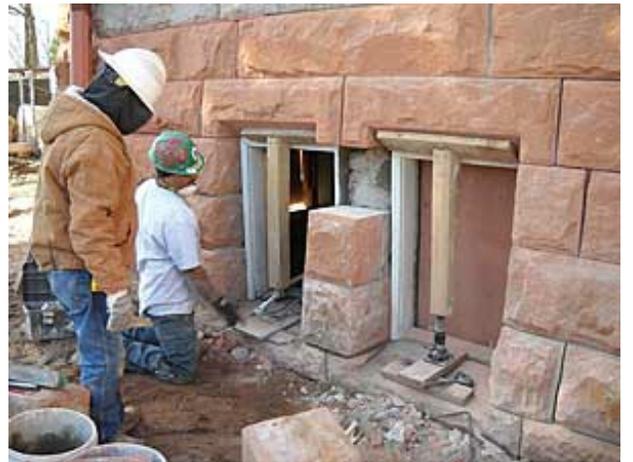
BRS was fortunate to discover large blocks of salvaged sandstone from the demolition of other buildings from the same era as Treat Hall. "For years and years, they had been sitting in a salvage yard," said Maas. "It was perfect for this project, and we certainly needed it. We purchased numerous pallets of stone, and we were able to carve the replacement pieces. It made it easier for us because we were able to replace a lot."
