# Restoring the Historic Coke Ovens of Redstone, CO

By Benjamin van Loon

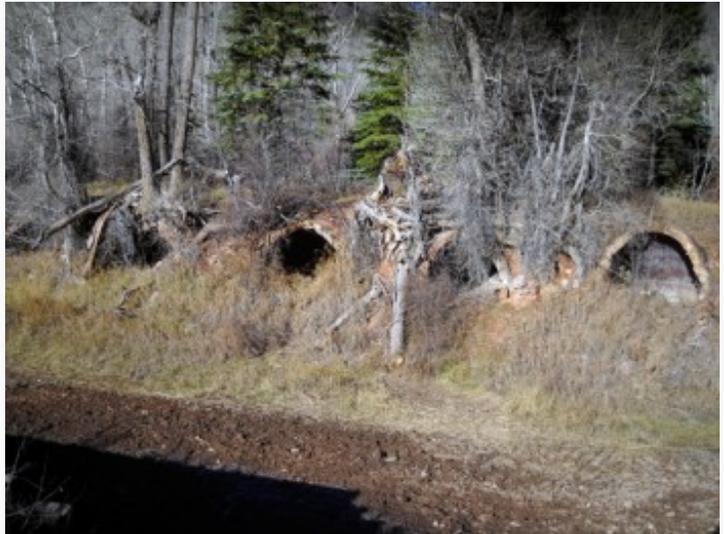
Deterioration and overgrowth had to be cleared before BRS could begin imagining what the original ovens looked like.

Water damage, resident wear, and routine neglect contributed to the poor condition of the coke ovens when BRS began. “[The site had] endured over 100 years of deterioration, stolen bricks, and use by campers and travelers,” Baker says. A historic commission in Redstone recognized the significance of the ovens and enthusiastically accepted BRS’s bid to repair the site, and immediately the firm set about clearing tons of garbage, brush, and overgrowth.

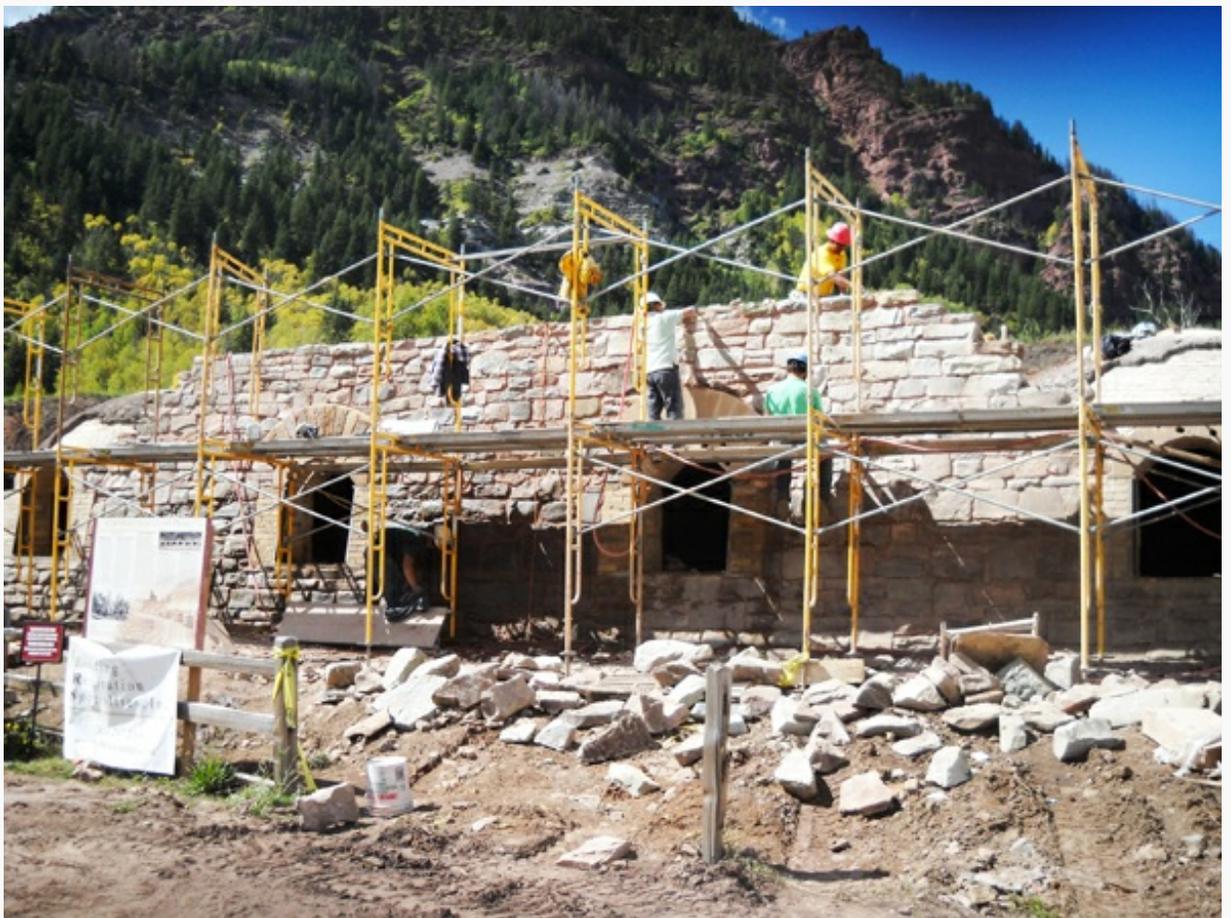
Committed to authenticity, BRS tracked down the appropriate stone and firebrick material to rebuild the ovens and the stone wall fronting them.

Although the ovens are no longer being used for firing, BRS still had to find the appropriate firebrick material to authentically rebuild the old ovens. And, because of the beehive-style design of the structures, BRS had to cut the bricks by hand. “They used to ship the ovens in kits that only needed to be assembled, but because these particular kits are no longer available, we had to hand cut approximately 20,000 bricks,” Baker says. “In addition to the ovens we were restoring, we also built four new ovens to the same specifications as the old ones.

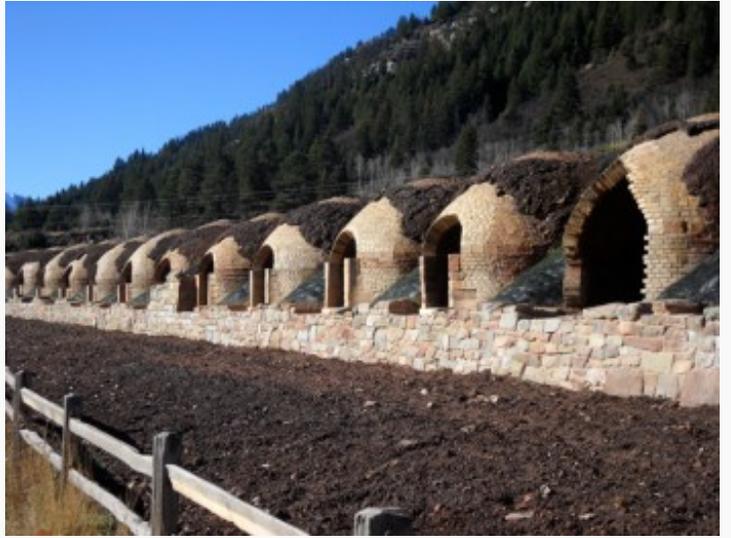
BRS hand cut about 20,000 bricks to fit the ovens' distinct shape.
